Manhole Inspection Summary

Manhole # S370__027MH

Insp Date: **1/23/08 10:14 AM**

Location Address: **317 e.hambergst**

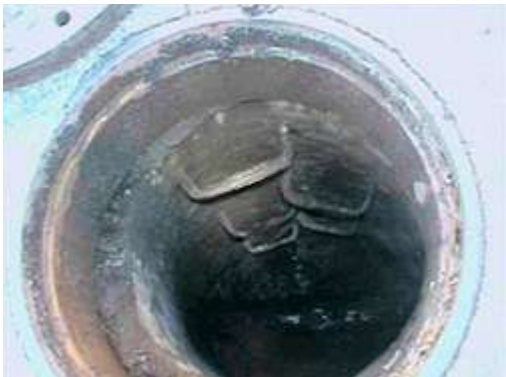
Defect 1

Frame Offset: **3** (in.) Condition: ☐ Sound ☐ Cracked ☒ **Leaks**

Infiltration: ☐ None ☒ **Joint** ☐ Cracks ☐ Mortar ☐ Roots ☐ Wall

Steps Count: **5** Missing: **1** ☒ **Corroded**

frame offset, missing/corroded steps,
infiltration from borbel joint

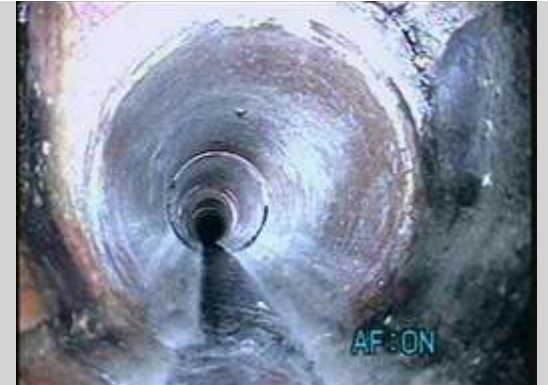
12 O'Clock Outflow

8 in. Circular Gravity Sewer
Pipe Out @ 12 O'Clock

Infiltration: **None** Pipe Seal Cond: **Unknown**

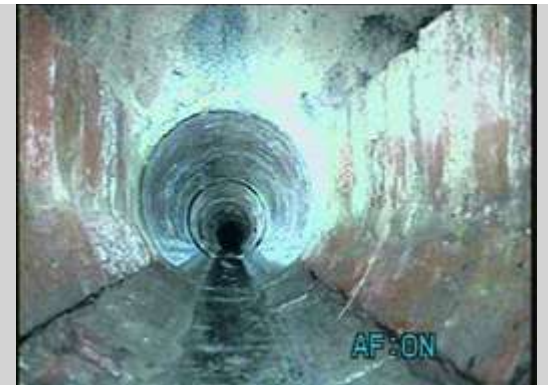
6 O'Clock Inflow

8 in. Circular Gravity Sewer
Pipe In @ 6 O'Clock

Infiltration: **None** Pipe Seal Cond: **Unknown**
